**DEPARTMENT OF TRANSPORTATION****DIVISION OF ENGINEERING SERVICES**

Contract #: 04-0120F4Cty: SF/Ala Rte: 80 PM: 13.2/13.9File #: 69.28**WELDING INSPECTION REPORT****Resident Engineer:** Siegenthaler, Peter**Address:** 333 Burma Road**City:** Oakland, CA 94607**Report No:** WIR-016556**Date Inspected:** 22-Aug-2010**Project Name:** SAS Superstructure**OSM Arrival Time:** 1900**Prime Contractor:** American Bridge/Fluor Enterprises, a JV**OSM Departure Time:** 700**Contractor:** Zhenhua Port Machinery Company, Ltd (ZPMC), Changxing Island **Location:** Shanghai, China**CWI Name:** See below**CWI Present:** Yes No**Inspected CWI report:** Yes No N/A**Rod Oven in Use:** Yes No N/A**Electrode to specification:** Yes No N/A**Weld Procedures Followed:** Yes No N/A**Qualified Welders:** Yes No N/A**Verified Joint Fit-up:** Yes No N/A**Approved Drawings:** Yes No N/A**Approved WPS:** Yes No N/A**Delayed / Cancelled:** Yes No N/A**Bridge No:** 34-0006**Component:** Tower and OBG Components**Summary of Items Observed:**

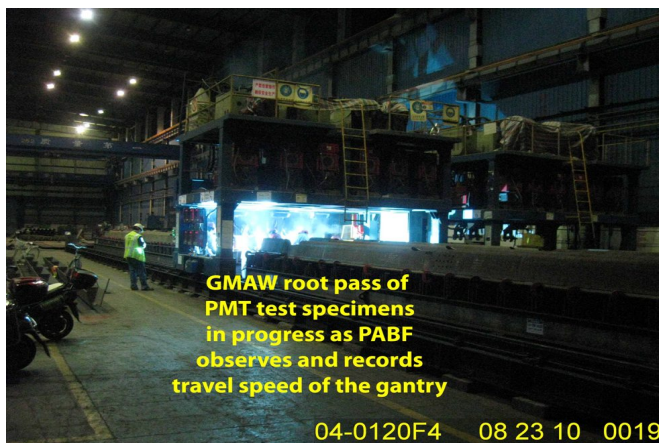
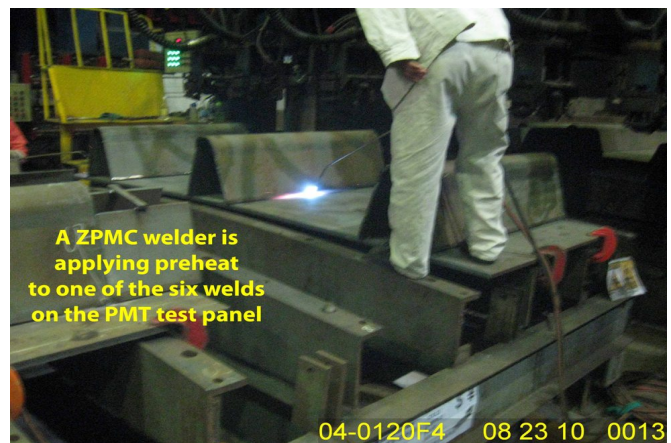
from position 1 through 6, respectively, as follows: 059418, 059421, 059443, 201788, 059403, 059416. ZPMC personnel used an oxy-fuel torch to preheat the specimens to above 60°C and the interpass temperature was still above 60°C without additional heating, in conformance with WPS-B-T-2342-U1-(U-rib)-5. See photos below. The start time for welding of the 3–12mm x 20mm specimens was approximately 0015 hours on 8/23/10 and the finish time was approximately 0138 hours. This QA Inspector randomly verified and documented the welding amperage, voltage, and travel speed during the gas metal arc welding (GMAW) and submerged arc welding (SAW) processes, welds 1 thru 6 at the completion of both the GMAW root pass and SAW cover pass. The welding variables recorded by PABF appeared to comply with WPS-B-T-2342-U1-(U-rib)-5. The welds were visually inspected by PABF and this QA Inspector. PABF informed this QA Inspector that all six welds were acceptable and after random inspection this QA Inspector concurred. This QA inspector randomly witnessed ZPMC ultrasonic testing (UT) inspector, identified as Xu Wei, perform UT on each of the 500 mm test welds for depth of penetration and conformance. This QA Inspector selected fifteen designated locations for macroetch sampling per contract requirements. Each macroetch sample location was stamped by ZPMC personnel with the number 3163, a number 6, chosen randomly by this QA Inspector as a verification mark, and an individual progressive macroetch identifying number for each macroetch sample. See photos below. After removal from each of the weld test specimens, polishing, and acid etching of the selected end, the macroetch samples were evaluated using a 7X optical magnifier and accepted by PABF and this QA Inspector.

All fifteen sample macroetch samples appeared to meet requirements and were noted to appear acceptable. See Caltrans U-ribs PMT Inspection Sheet, ZPMC Production Monitoring Test Plate Inspection Report, and Caltrans Macro Etch Log - all dated 8/23/2010 for additional information.
